Re: ██████████ Bus Garage, ██████████
██████████ NY
██████████

The Structure

The Damage

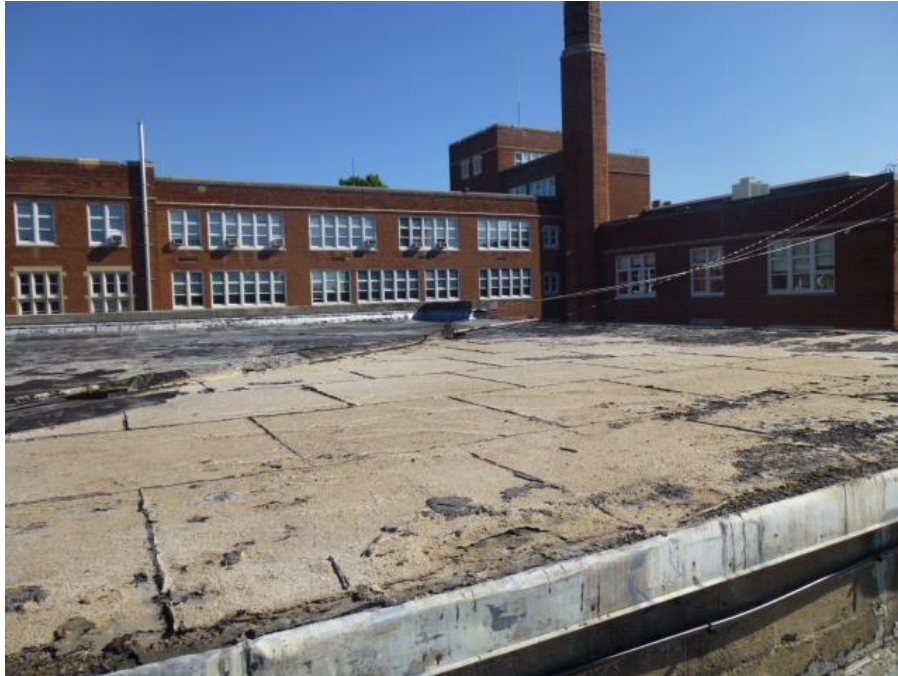
The larger section on the south end of the building is a rectangular-shaped, low sloped roof measuring approximately 2,589 sq. ft. including a factor for waste. This roof sustained damage to the SW corner of the roof where an approximately 560 sq. ft. triangular-shaped corner of the roof blew back from the edge. The corner remained attached and folded over

onto the field of the roof where it remained until it was discovered accidentally when viewed from an adjacent building. The building did not leak after the initial damage. The exact date of loss is unknown, however historical imagery on Pictometry.com shows the membrane to be in place on 3/12/2012 and it is likely that the DOL was Hurricane Sandy on 10/29/2012. The damage to the roof is consistent with wind failure based on the location of the failure at the corner of the building and the physical state of the folded over roof membrane. The decision to adhere the recovery insulation to the gravel without mechanical fastening is both the probable reason for the failure (poor adhesion to the gravel substrate) and the reason for no leaks after the failure (the underlying hot tar roof was not punctured when the new roof was installed) when the most recent torch applied, modified bitumen roof was installed.

The wind damaged SW corner of the south roof on the bus garage.

Given the fact that asbestos exists in the roof assembly, the roof must be removed as per the State Labor Law Industrial Code Rule 56 which prohibits the encapsulation of asbestos containing material. If the roof had not contained asbestos and it was determined that the roof could be overlaid without removal that exposes the insulation of sheathing (concrete roof deck), the installation may have been exempted from complying with the NY State 2010 ICC adopted Energy Code under 101.4.3.5. if the leveling board installed over the gravel was not considered "insulation". The removal of the roof however is required to comply with the Labor Law.

The [REDACTED] proposal states a scope of work that includes a 2,462 sq. ft. area which is the raw square footage of the south roof and the area of damage. The proposal includes removal of the all the roofing to the concrete deck and the transportation and disposal of the Asbestos Containing Material (ACM) in accordance with NYSDOL, EPA, and OSHA regulations.

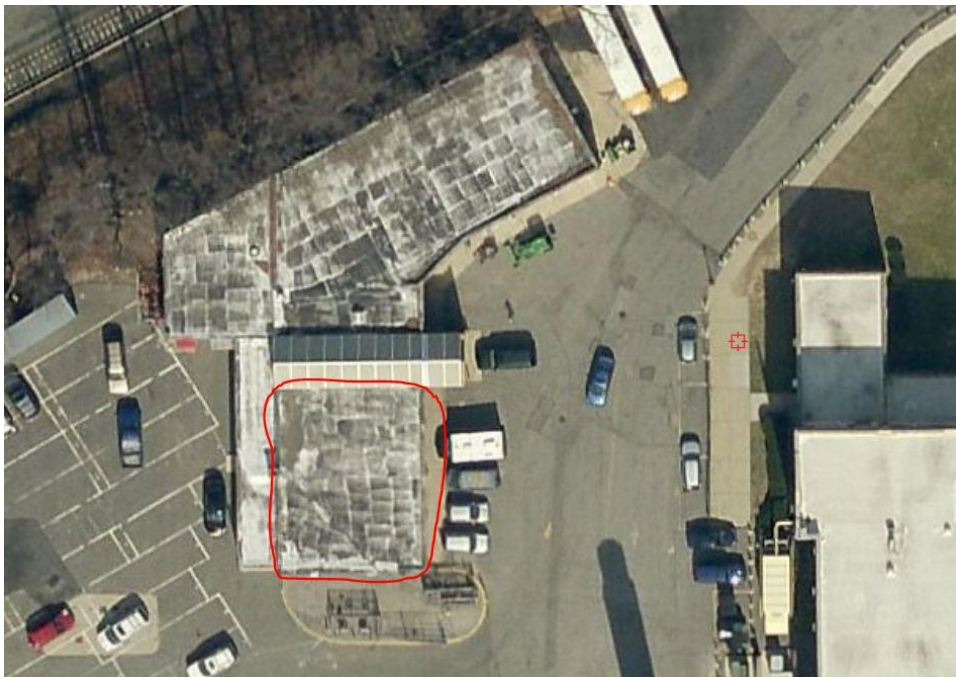
The 2,589 sq. ft. roof area with wind damage to 560 sq. ft. in the bottom left corner.

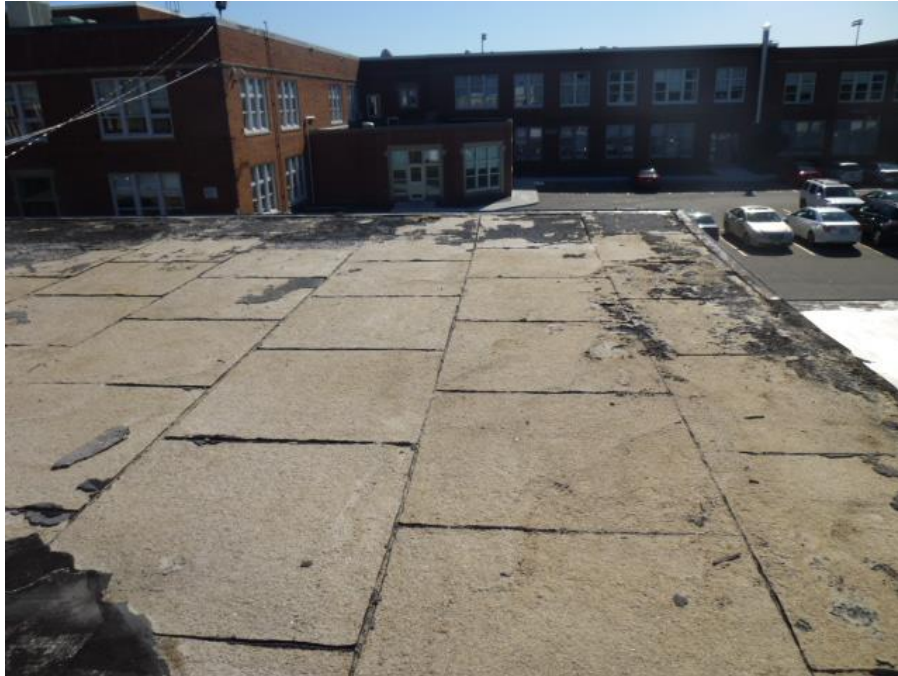
Exposed recovery board insulation.

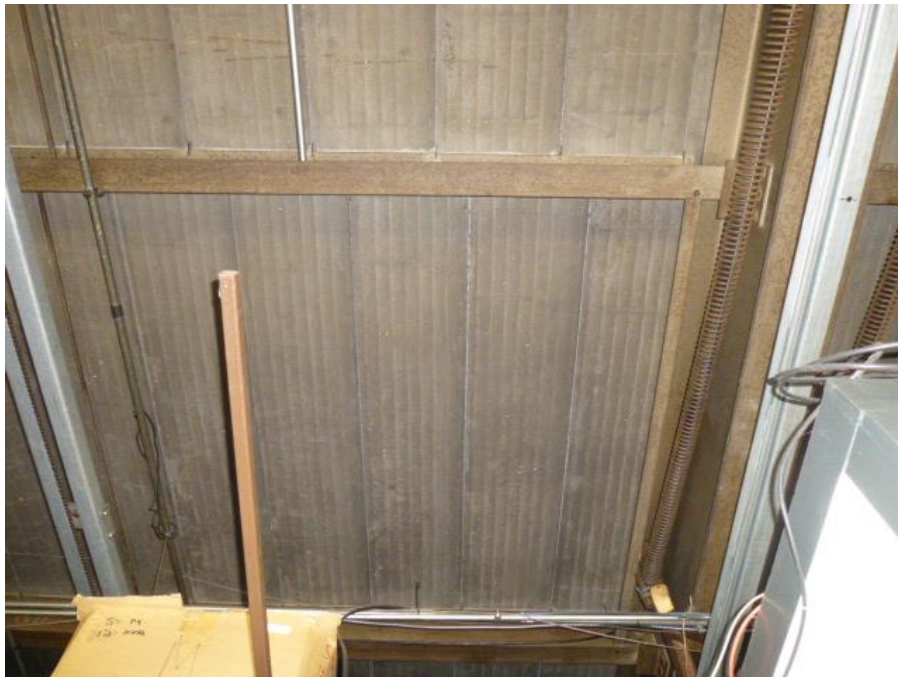
The overall building is a one-story, roughly "L" shaped, masonry structure with a central, steeply sloped, raised gable atrium with polycarbonate translucent panels and two large flat roofs toward the front of the building and two smaller flat roofs at the rear. The building is a bus garage utilized for the repair and maintenance of school buses. The flat roofs are covered in a modified bitumen roof membrane and covered in asphalt-based aluminum paint. These uppermost roof coverings were installed over the original roofs. The reroofing process included the installation of a wood fiber insulation over the gravel surfacing of the original hot tar built up roofs. It appears that the insulation was adhered to the original roof possibly after the gravel surface was prepared by vacuuming or brooming the loose gravel and possibly priming the remaining gravel, embedded in the flood coat of the hot tar roof. The building has a concrete plank deck clipped to steel ceiling beams.

Concrete panel deck clipped to steel I-beams.

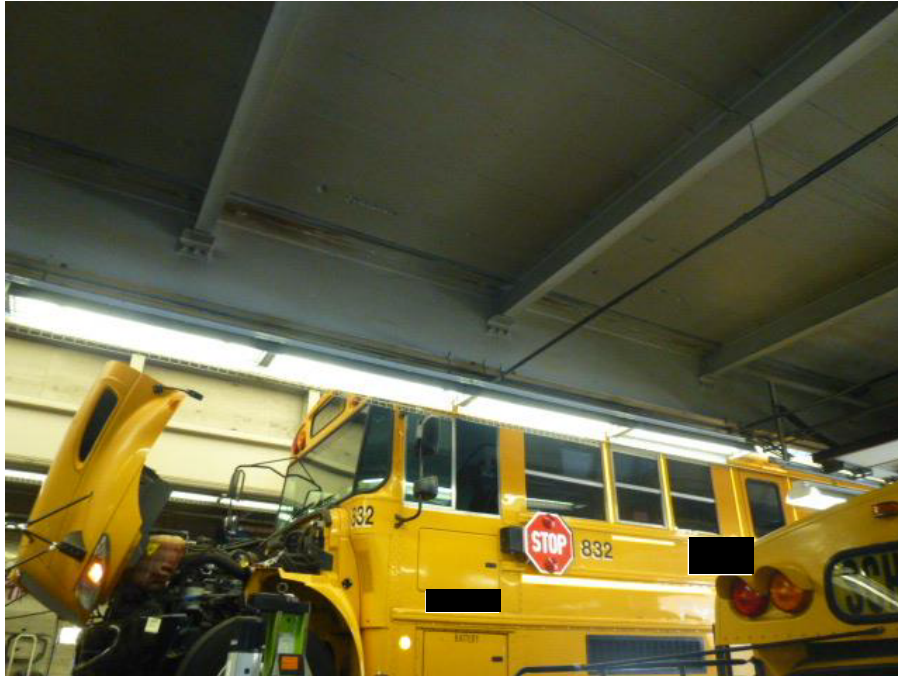
No attic.

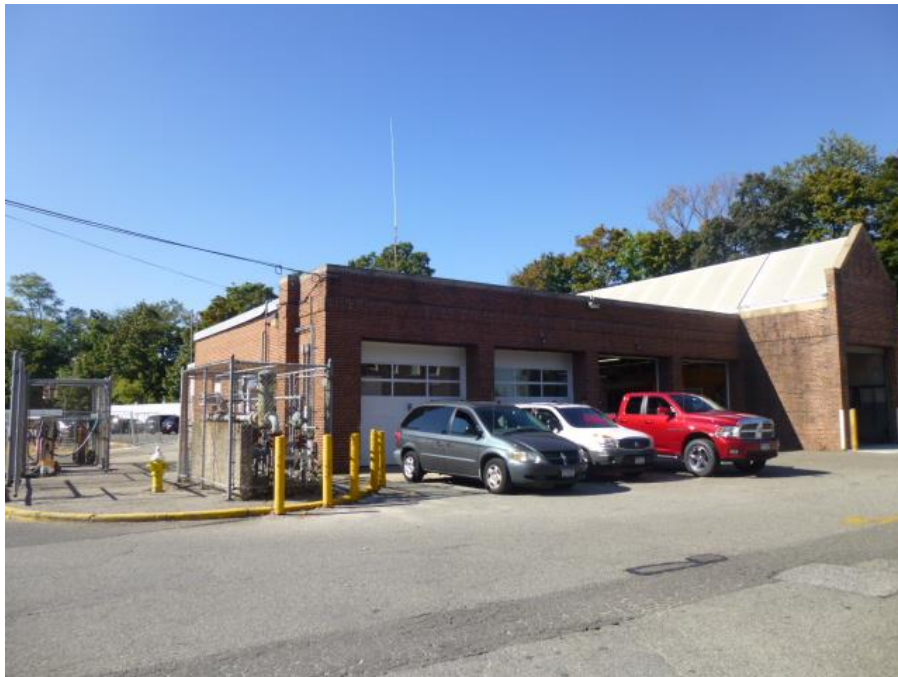
Building not metal.
