# Condominium Association, Inc. Roofing Systems Report

May 19, 2016

## **Purpose**

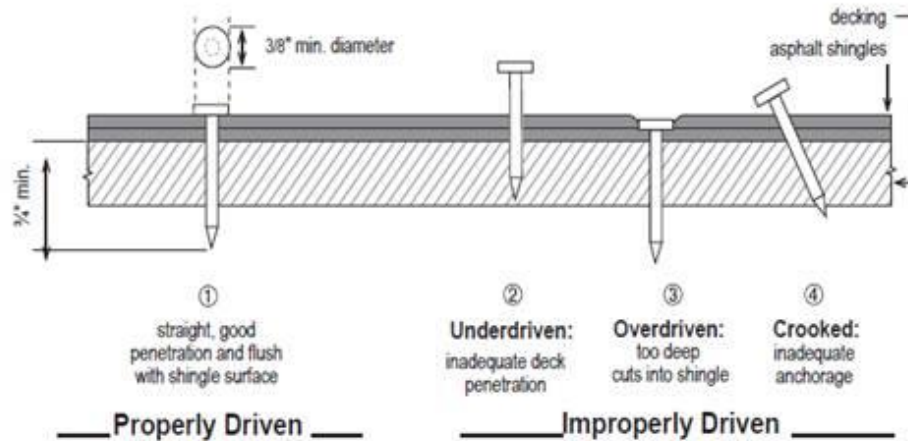
Figure 3: Nails #2 and #4 are both “popped nails”.  
 Asphalt Roofing Manufacturers Association, “Nail Application of Asphalt Shingles for New and Re-cover Roofing, Technical Bulletin”.

“Nail pops” is usually a misnomer. Often an exposed nail head can be seen when it makes a hole through the shingle above. When a nail head protrudes up through the shingle above it is termed a “nail pop” but the nail has most likely not moved at all. The nail pop is a result of nails not being driven all the way in. When a nail is not driven with the nail head flush against the shingle it is being used to secure, it will eventually create a hole in the shingle above over time. Nails are driven into shingles using pneumatic guns at a rapid pace when shingles are installed. It is common for a shingle installer to shoot 5 nails into adjacent shingles in less than 2 seconds. If the correct amount of air pressure is not activated for each fastener and the fasteners are not checked a resultant amount of “popped nails” will occur. In time with gravity and heat the shingles over the popped nail will work down over the head and create a hole. This is a workmanship issue associated with improper installation and not a result of wind or structural movement. A popped nail can also occur if a pneumatic gun is not held square to the roof surface and part of the head contacts the roof but the other edge of the nail head sticks up like a knife edge against the underside of the shingle above. Nail pops can be addressed by removing the popped nail and installing a new nail adjacent to the original location after the seal tab on the shingle is separated and the shingle is lifted. This work requires skill and experience in the separation of the seal tabs so as not to damage the existing shingle. Separating the seal tab requires that the shingle be “hand sealed” with a caulking or mastic after the popped nail is removed. The location of the original hole must also be sealed.
