Re: John & Jenna Smith / 123 Roosevelt St., Queens, NY 11355
Insurance File No. 15-345678

I inspected the above address on 4/15/2015 for roof damage. The owner, Mr. Smith, was home at the time of my inspection. The structure is a two-story adjoined townhouse with a low slope (flat), granular, asphaltic, roll membrane roof system. The roof appears to be in the range of 20 to 25 years old. There is a steep, mansard, slate roof and lower doorway roof in the front. The slate roofs appear to be more than 50 years old.

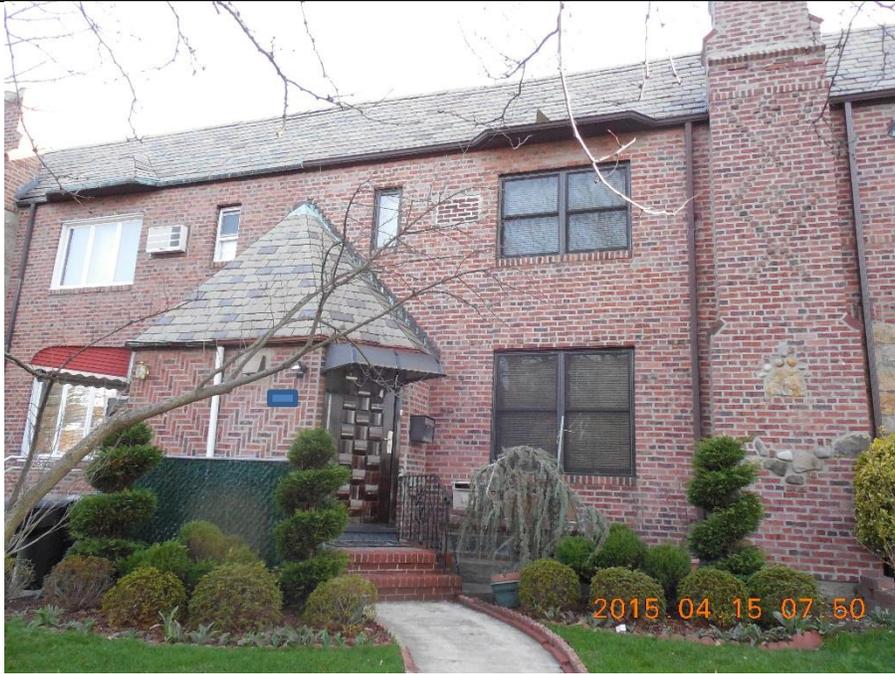
Ground view, front of house.

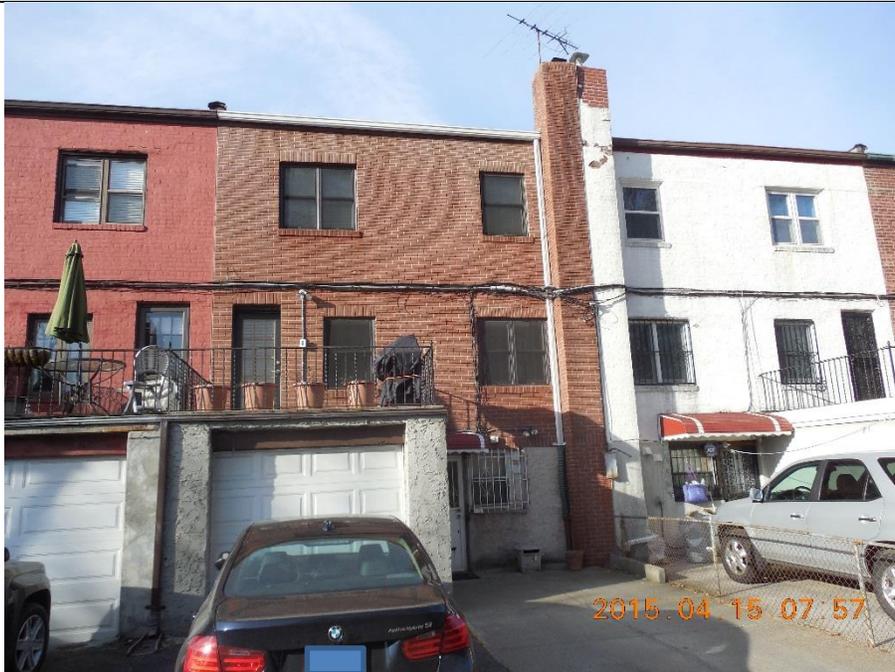
Ground view, back of house.

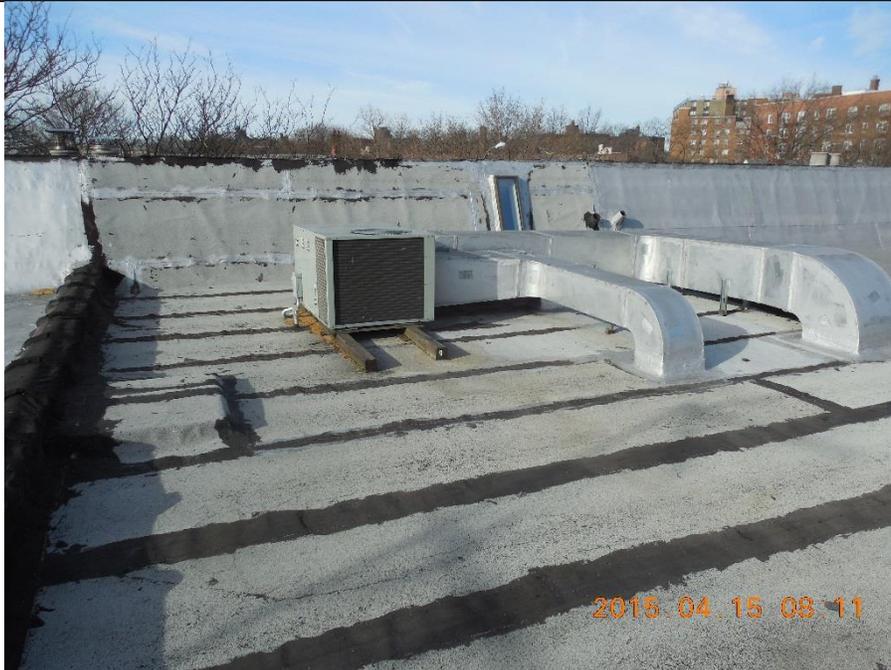
- All the seams in the granular roll roofing have been repaired years ago. The seams have been covered with asphalt cement and fabric. All the seam repairs are deteriorating and drying out. The seam repairs are all failing. These seam repairs appear to have been installed years ago to repair the original membrane seams that were separating.

Overview of roof, back to front. All seams have been repaired years ago.

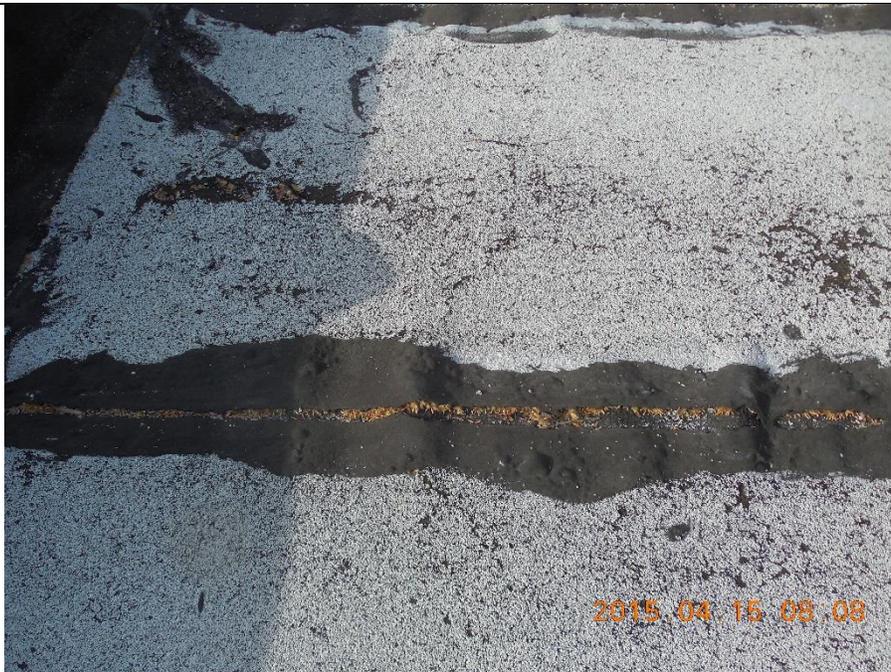
- The granular surface membrane is worn out. The roof membrane is dried out, cracked, blistered, voiding granules, and worn through in numerous locations. The granular surface roof membrane has exceeded its serviceable life due to natural wear and tear, age, exposure, and lack of maintenance.

Failed seams and worn out membrane.

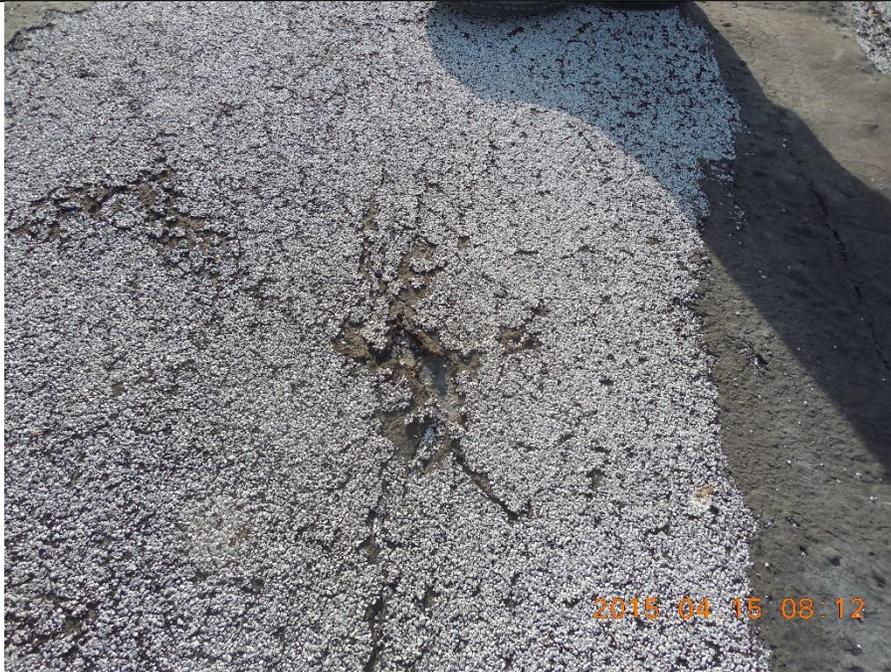
Roof membrane has worn through in numerous locations.

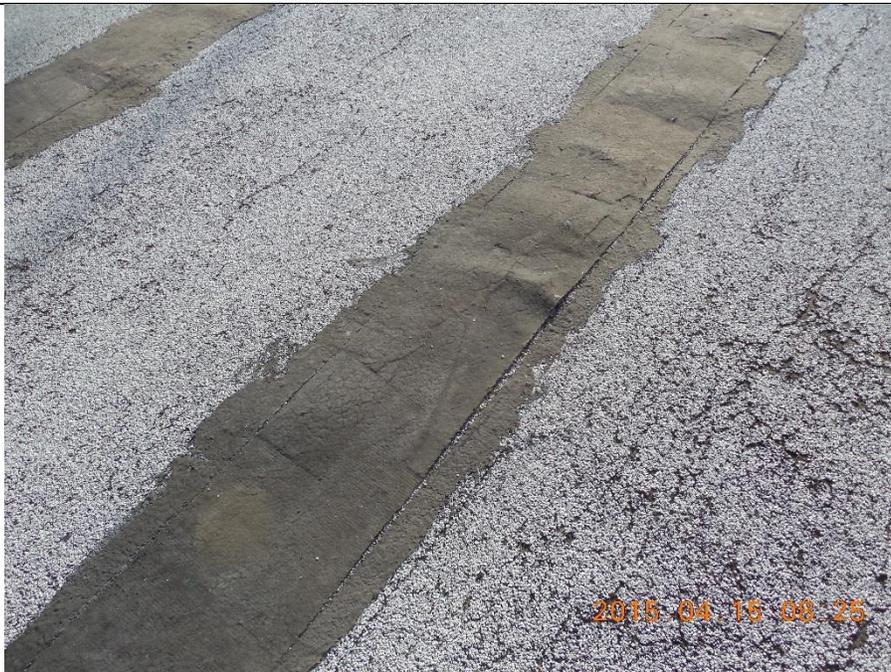
Repairs over seams are failing. Membrane is cracked and split.

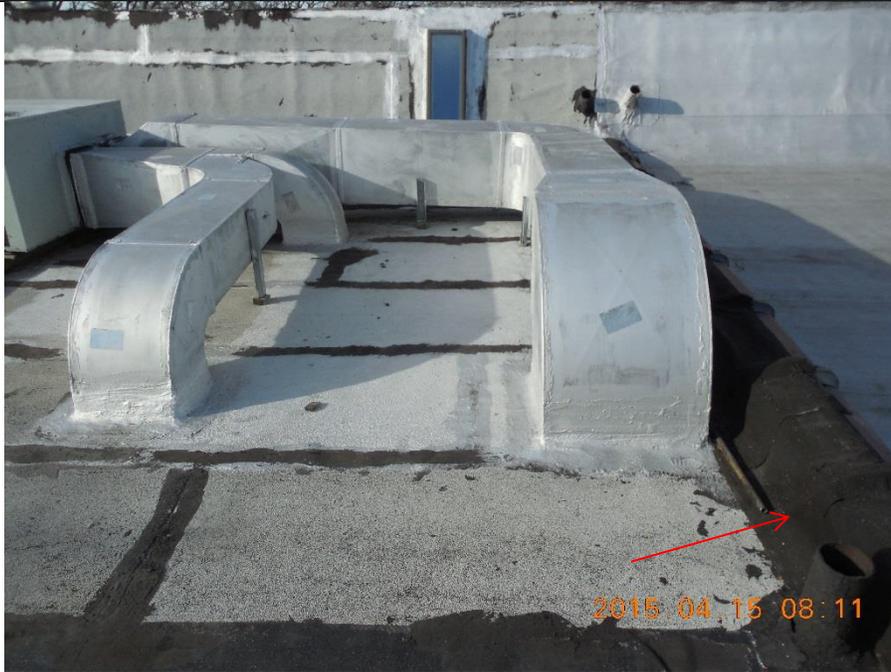
- There is no proper metal or membrane flashing on the parapet walls and roof penetrations. The parapet wall sections have been covered with smooth surface, modified bitumen membrane. The modified membrane on the walls appears to be 7 to 12 years old. The modified membrane on the side walls overlaps the granular roofing on the roof surface. The seal between the modified material and the flat roof material has created a seam that runs down the entire length of the roof. This overlap is likely allowing water to infiltrate beneath the roof system.
- There is no proper metal or membrane flashing at the roof penetrations, such as ducts, vent pipes, and the chimney. These roof penetrations are sealed with unsupported flashing cement. The asphalt cement flashing is failing due to age, exposure, lack of maintenance, and improper installation.

No proper flashing at duct penetrations. Modified bitumen membrane has been installed over parapet wall along northeast adjoining wall (red).

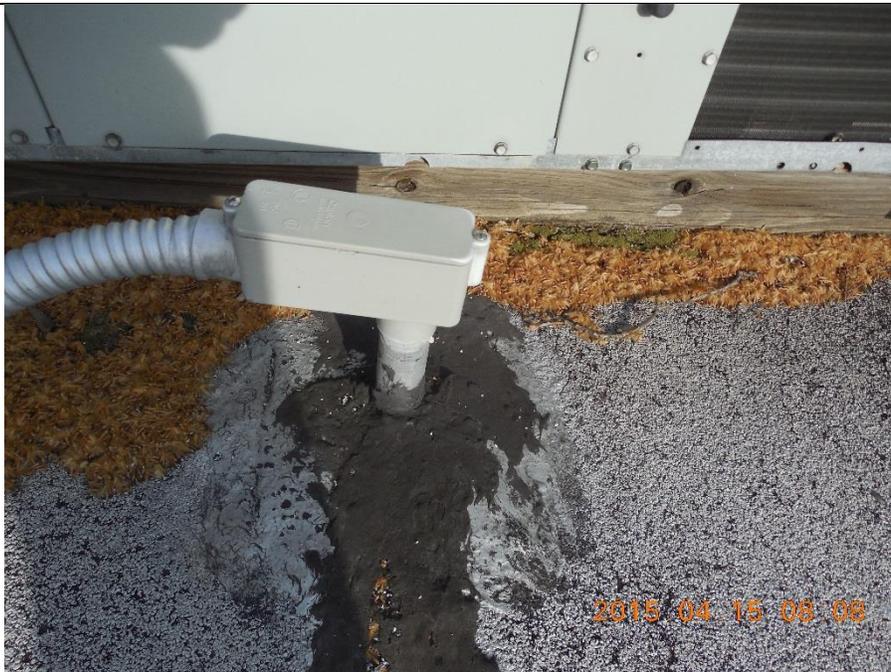
No proper flashing at conduit penetrations.

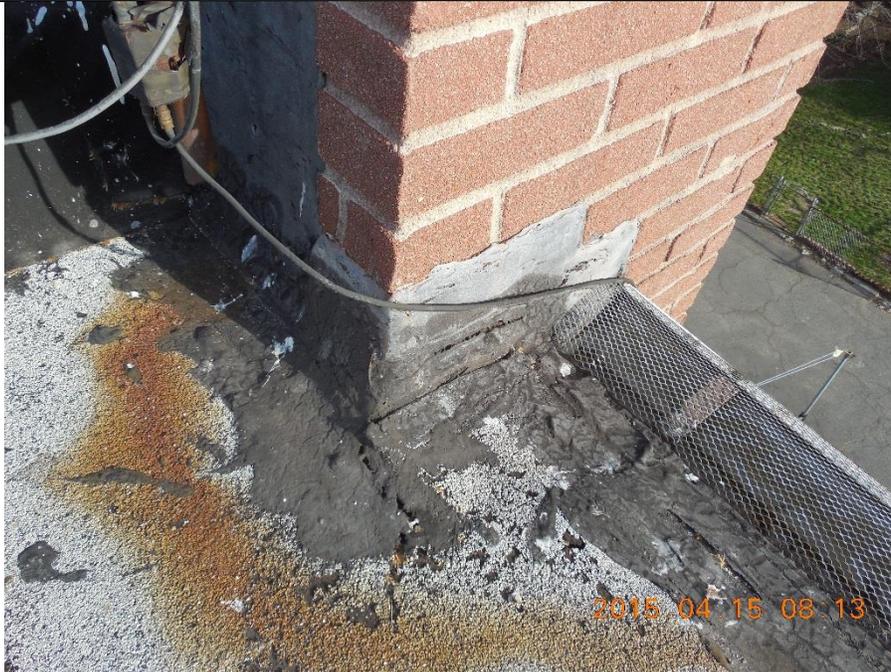
No proper flashing at chimney. Failed flashing and membrane at base of chimney.

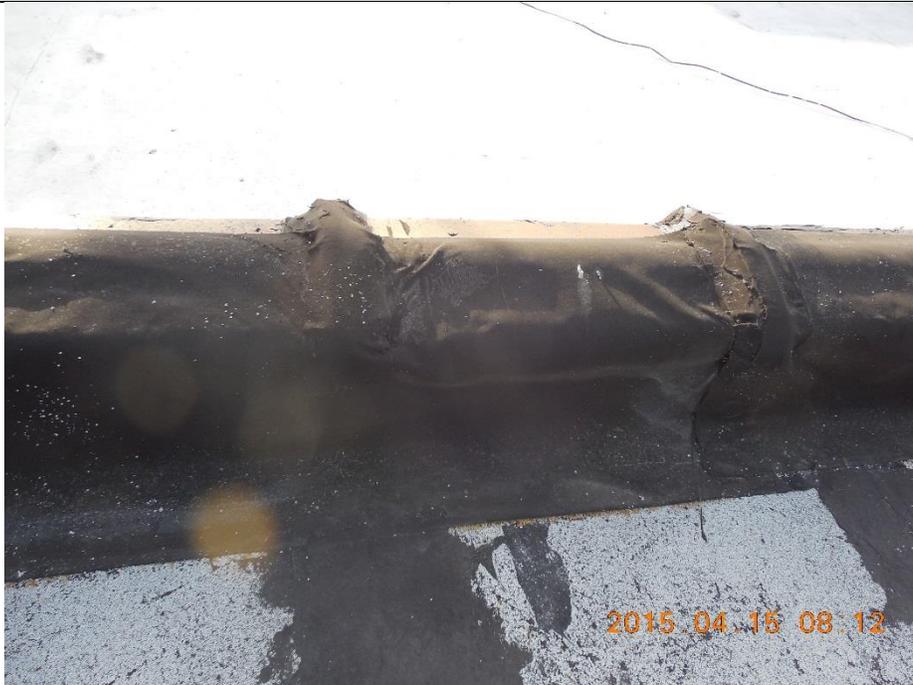
Modified bitumen membrane on parapet wall. Water can seep under roof system where modified bitumen overlaps granular surface roofing at perimeter of roof.

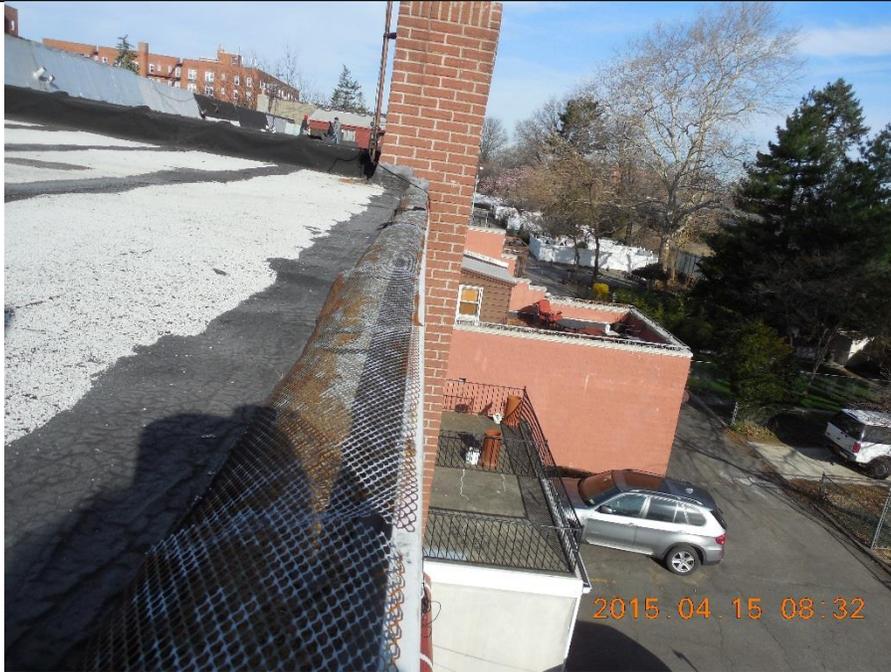
- The elevation of the gutter is higher than the back edge for the roof membrane, resulting in standing water and lack of positive drainage. This back edge of the roof has recently been coated with asphalt roof cement in an apparent attempt to stop water seepage. When a gutter that is elevated fills with water, overflow will occur at the back edge of the gutter and allow water to seep under the roof membrane. Overflow on a properly-situated gutter should flow over the outside edge of the gutter and not against the roof system.

Overview of back edge of roof with elevated gutter.

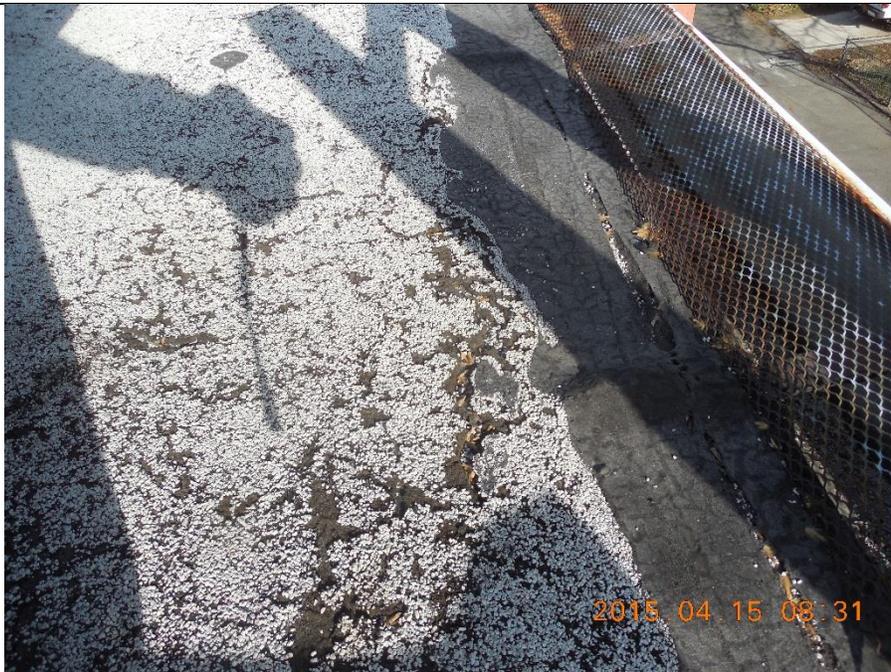
Worn out roof above gutter.

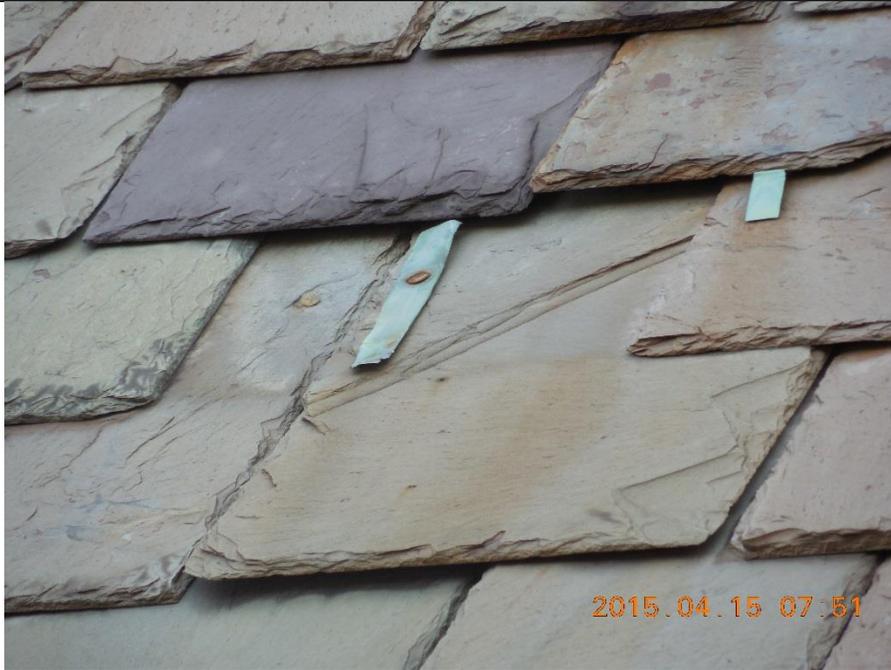
There were 2 visible missing/dislodged slates on the front of the house. One of the missing slates was a previously replaced slate that was secured with a copper strap. The copper strap failed over time, allowing the slate to slide free. The copper straps will bend and fail naturally due to the weight of the slate acting on the straps over time. The other dislodged slate is from the top of the roof hips over the front door. This slate became dislodged and slid into the gutter. It is common for slate roofs of this age and type to require periodic maintenance including replacement/reinstallation dislodged slates. The 2 dislodged slates on the front roofs have been caused by age, exposure, and natural wear and tear and are not due to wind or storm damage.

Missing slate on front upper roof. Copper strap failed from years of exposure.

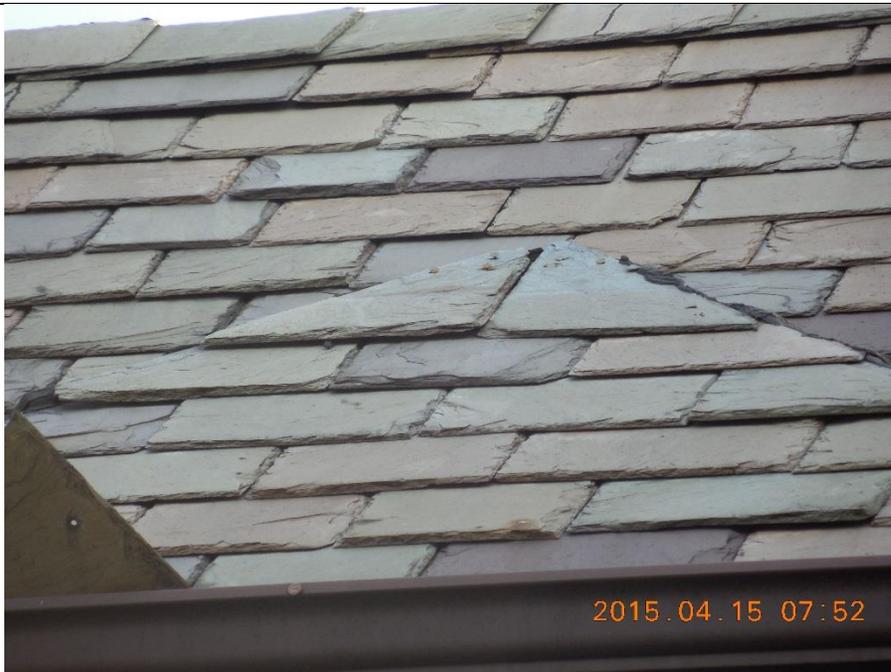
Dislodged slate from top of doorway roof. Slate is in gutter (bottom left of photo).
