The following report has been prepared to explain the roof and gutter conditions at the above site.

The Inspection

Roof and Gutter Drainage

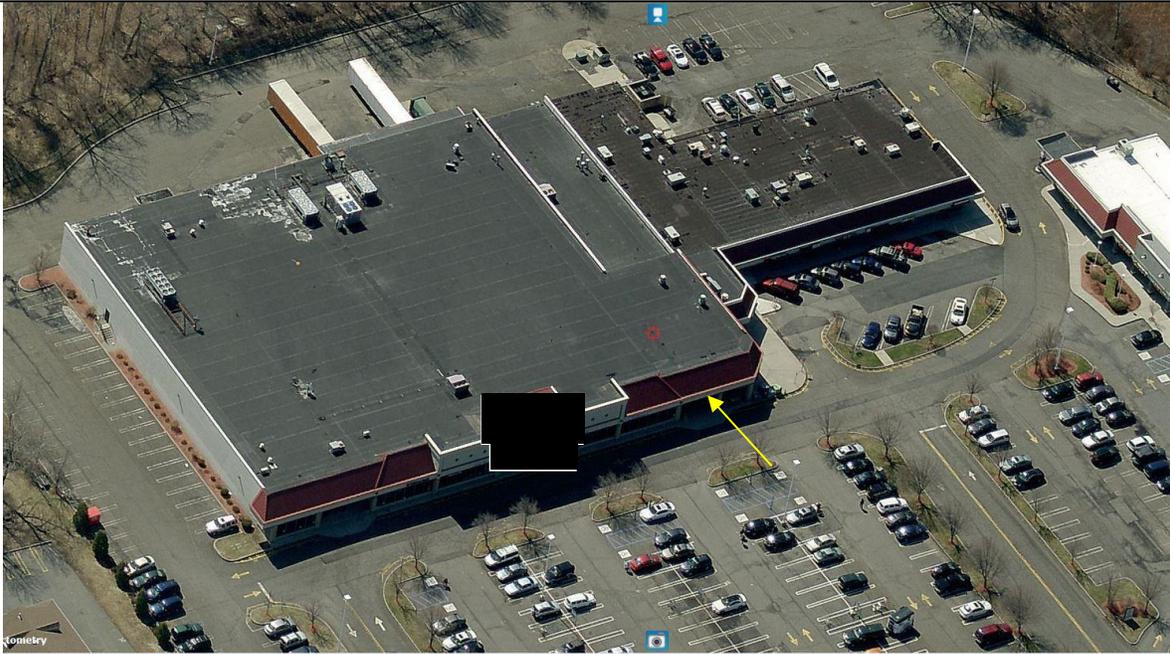
The [redacted] building in [redacted]. The west entrance roof is indicated. Note the shading of the front columns in this image taken in March of 2011.

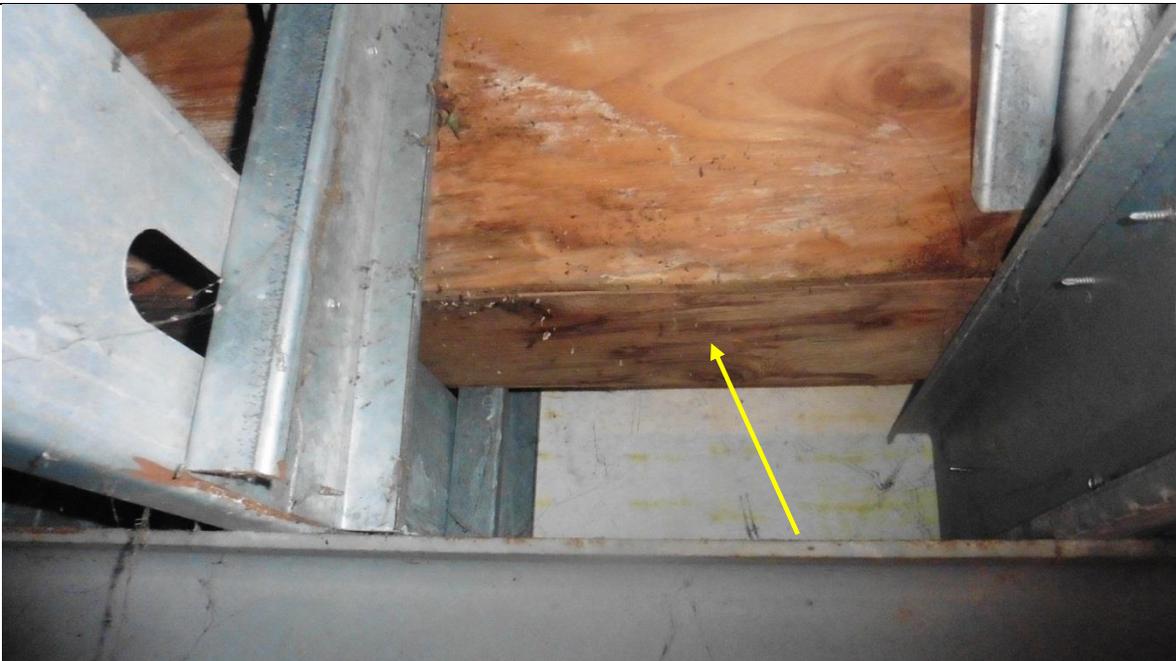
- Some of the drain outlets are constructed with copper drain tubes inserted into the larger PVC pipe below without a positive connection. Others are positively connected using PVC piping from the drain fixture and downward. The non-connected drains will overflow inside the framing of the soffit during the winter when the drain lines inside the masonry columns are frozen. Staining on the plywood gutter lining seen from inside the soffit indicated that this type of seepage was occurring.

The plywood seen here is the framing of the recessed built-in gutter. Note the water staining.

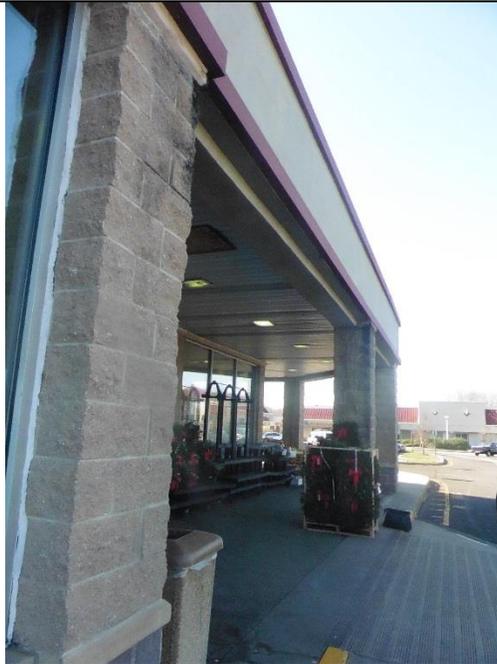
- The open ends of the standing seam panels can lead to minor seepage during wind driven rains as can the gap between the panels and the drip edge.
- The entire built in gutter and roof area exist above an unheated soffit space. The gutter system will cease functioning (draining water) as soon as the temperature drops below freezing. The likelihood of long periods of winter freezing of the interior drain lines is high. The interior drains run inside the masonry columns on the north side of the building. The masonry columns are almost perpetually shaded as is the entire front of the building. These internal drains, when exposed to multiple days of temperatures below freezing, would be expected to remain frozen for many days and even weeks while the mansard metal roofs that receive winter sunlight drain water/melted snow into the gutter and into the drains. This dynamic of frozen drains and melting snow would almost certainly result in repeated overflow of the gutter.

The drains for the gutter run inside the masonry columns, an almost perpetually shaded area in the winter.

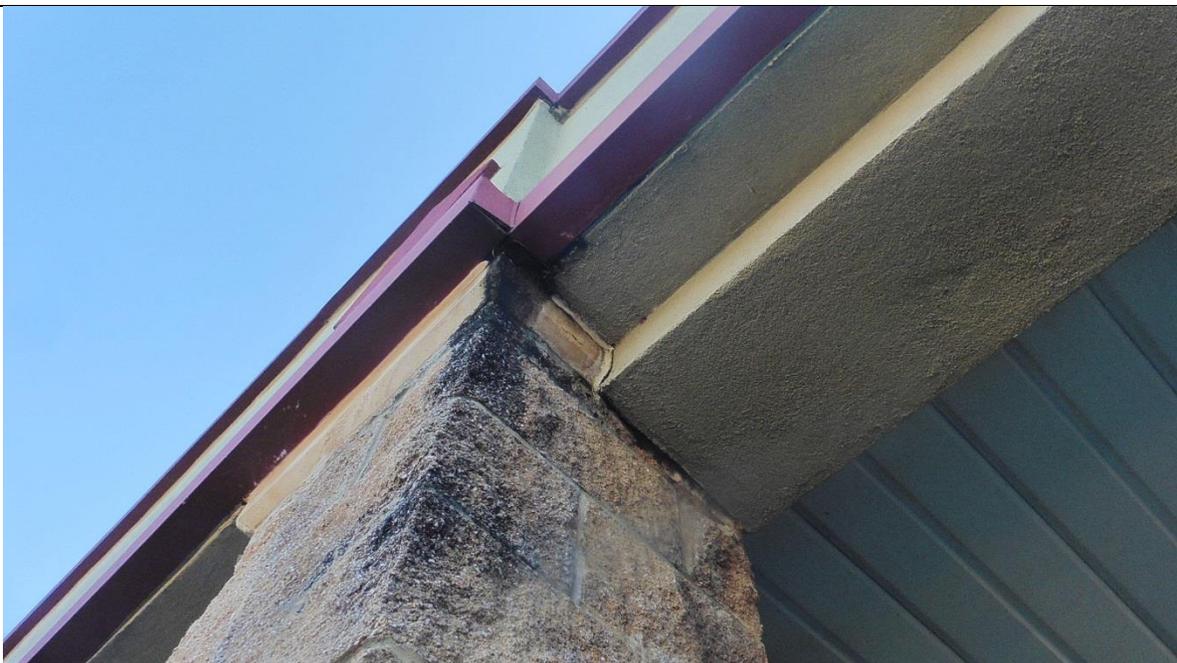
The roof, siding, and gutter have some design and workmanship issues which are leading to seepage into the soffit and drainage onto the sidewalk below. This is evident by the staining on the masonry columns and the deterioration of the building finishes.

Staining at the masonry column at the west entrance from water flowing off the red metal detail known as a water table.

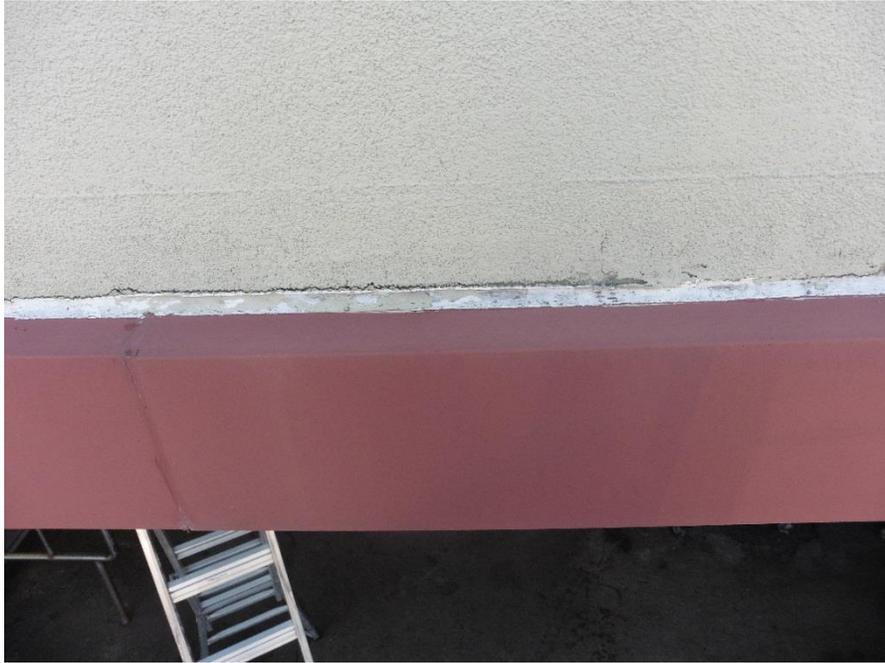
- The EIFS system is deteriorated and failed just above the red metal water table band at the bottom of the façade. Some sections of soffit and EIFS to the west and south are delaminated and drooping, indicating chronic seepage into the soffit area. Separations in the caulk joints between the water table detail and the start of the EIFS occur in many locations.

Separating caulking above the metal clad water table shelf. The EIFS siding is above.

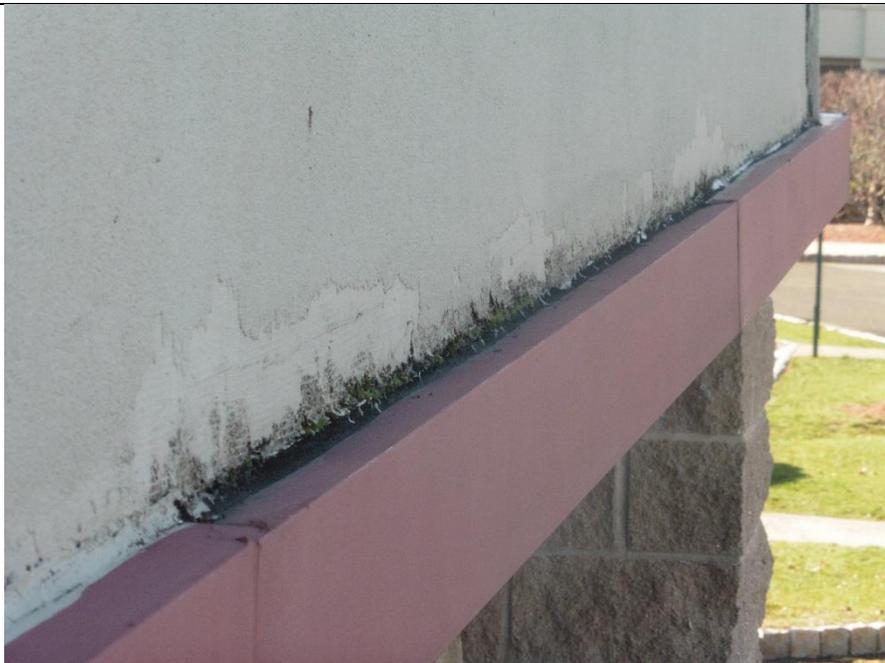
Deterioration of the EIFS is from water that accumulates on the water table band. This same water reaches the sidewalk.

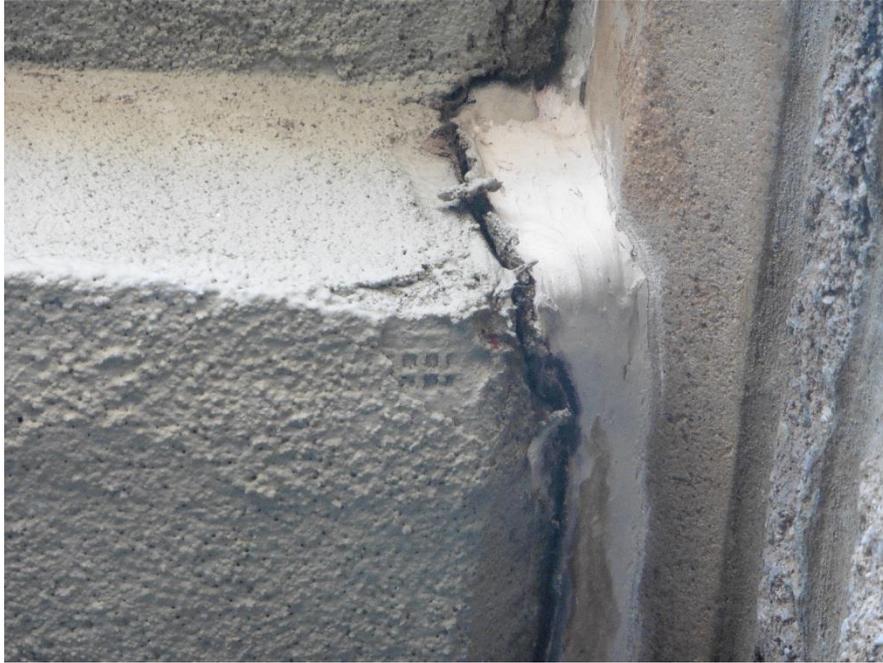
Deterioration and separation in the EIFS where it was used on a horizontal surface with no flashings.

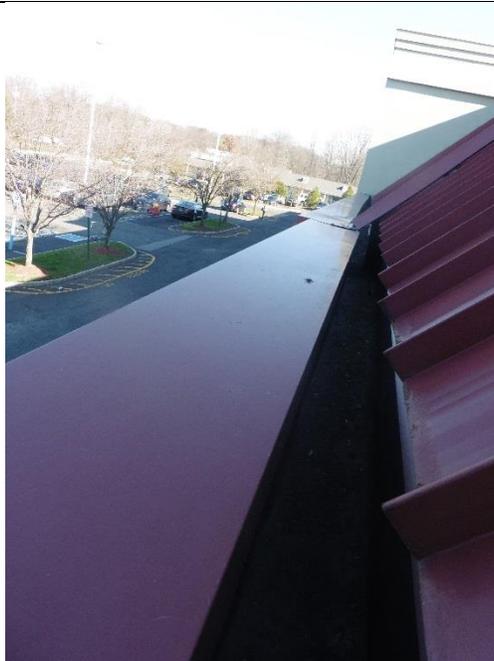
- The coping in front of the gutter is laid flat. Water can drain off the coping into the gutter or onto the sidewalk. The coping should have been installed with a slight pitch toward the gutter instead of flat. This would ensure that rain and snow would drain into the gutter and not onto the sidewalk. The coping top is a full 10 inches wide. This is a considerable area of shedding given the total linear footage of the coping. The coping is fastened with un-caulked face nails in a number of locations.

This image of the recessed built-in gutter and coping show the lack of slope in the coping.

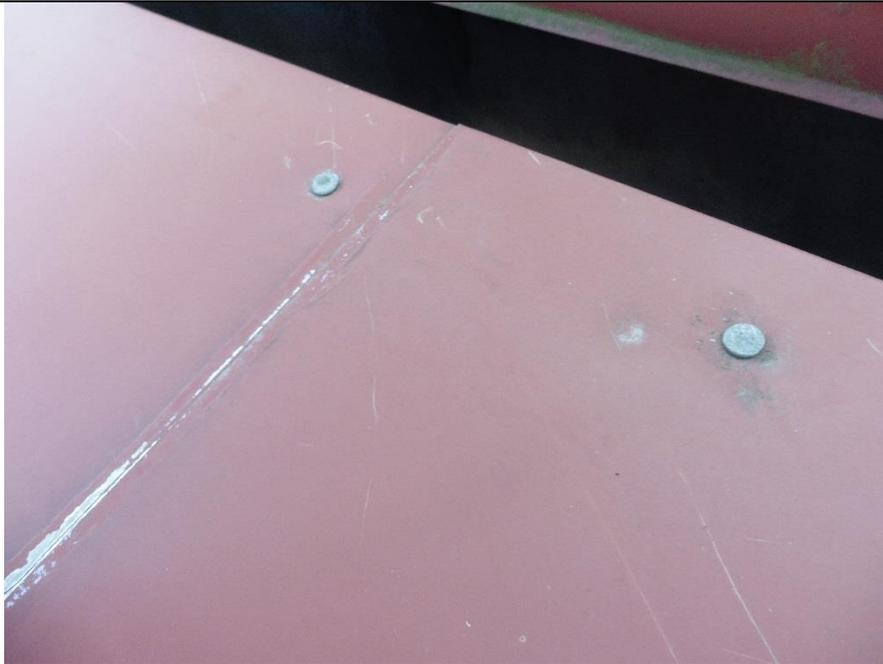
Face nails in the coping are not caulked.

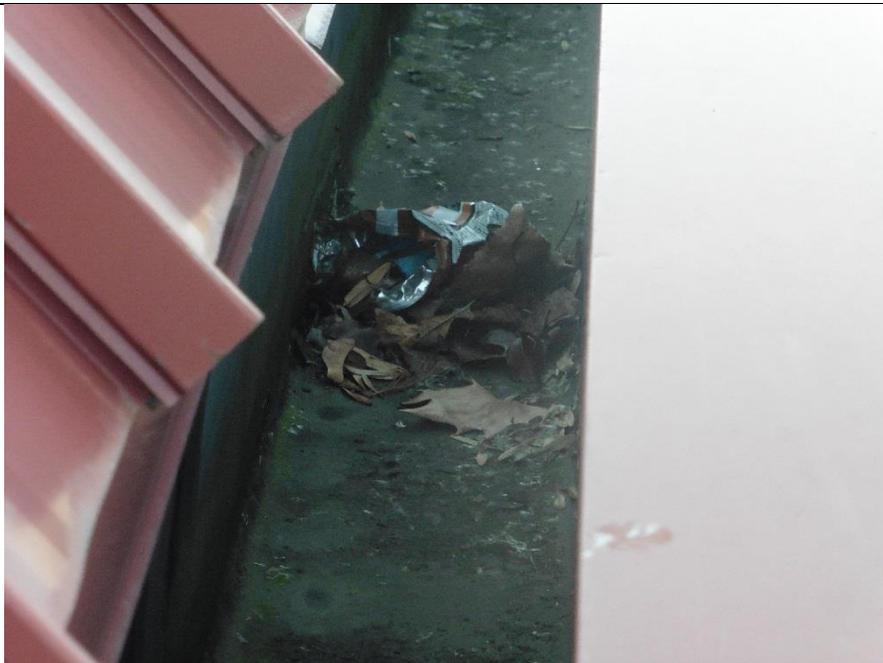
- The rubber gutter lining had accumulated debris blocking one drain completely and two other drains partially during our inspection. The large sizing of the drain lines and gutters is moot if the drain outlets are blocked. Blockage of the outlets with leaves and debris results, obviously, in the overflow of the gutter.

This accumulated debris is at a roof drain near the hatch.

The gutter trough on the north side of the building above one of two main entrances needs to be cleaned of leaves and debris at least twice each year. The clogging of the drains evident during our inspection and the failed and drooping soffit indicate a lack of proper maintenance. The soffit failure has occurred over a time period of many months at a minimum and likely over a time period of more than a year.

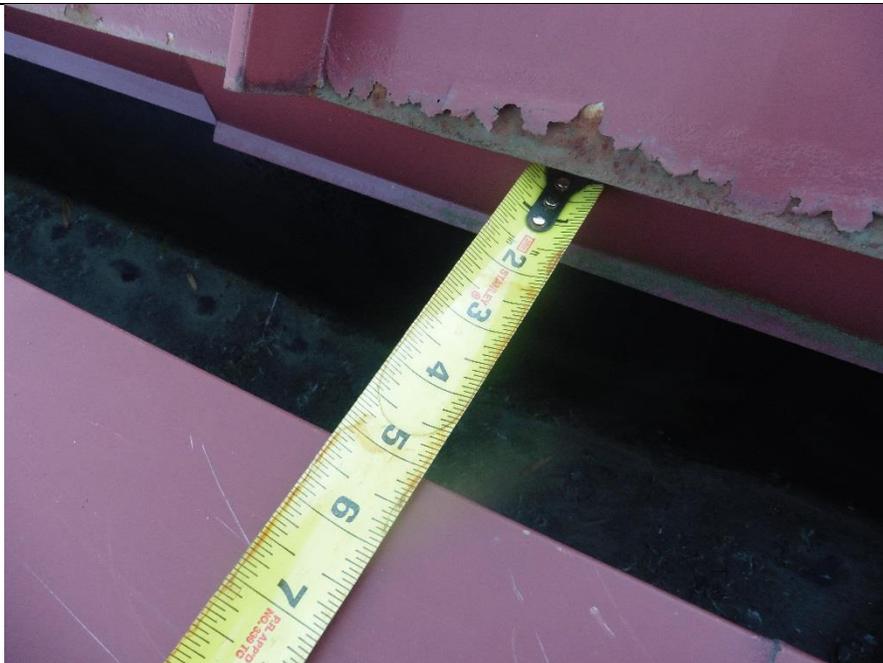
the gutter is equal to the height at the front edge times the gutter width (10.75 inches x 5.0 inches = 53.75 square inches). This is an excessively large gutter given the drainage area it is servicing. The roof panels, installed on a 45 degree angle are 11 feet long but have an exposure to the sky of only 8.5 feet when measured in plan view. This smaller area is called the design area. The design area is used to calculate the needed size of the gutter and downspout drains for a given rainfall intensity. One running foot of built in gutter measures 4.47 cubic feet in volume and drains a roof area that is effectively only 8.5 sq. ft.

The built in gutter is 5 inches wide.

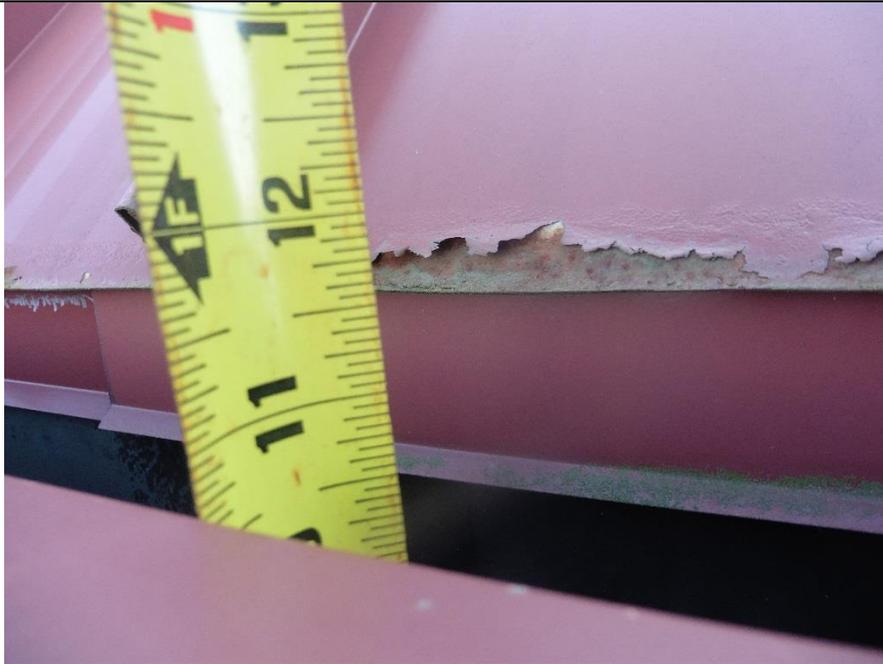
The gutter is approximately 10.75 inches deep at the front.

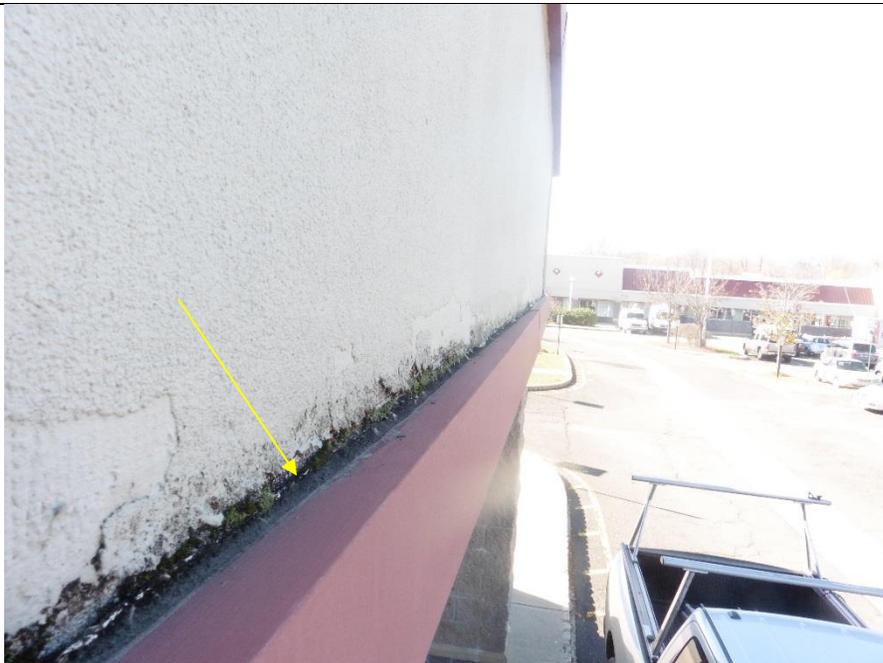
EIFS deterioration.

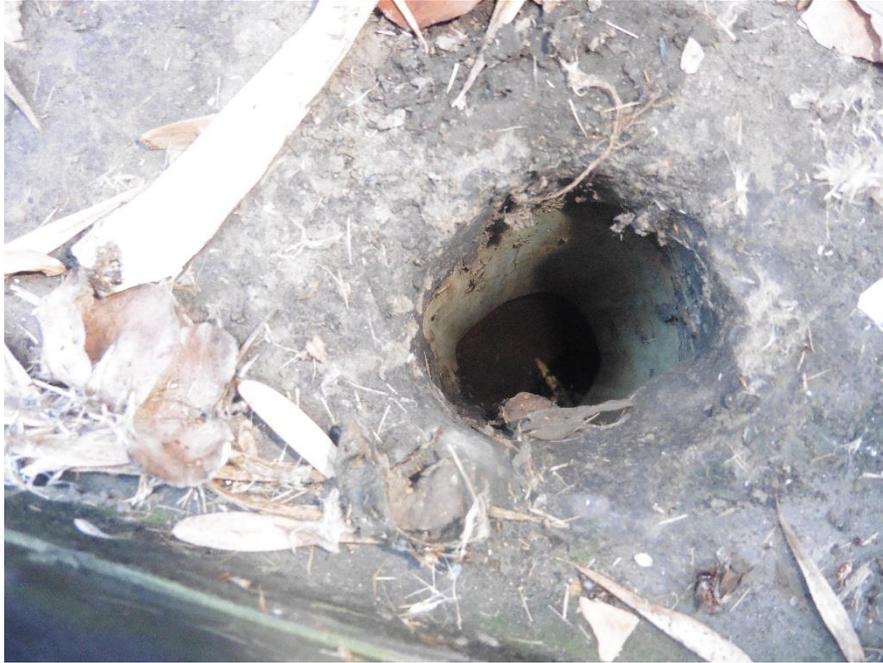
This 2 inch diameter copper drain tube is inserted into, but not sealed to, the PVC internal drain pipe.

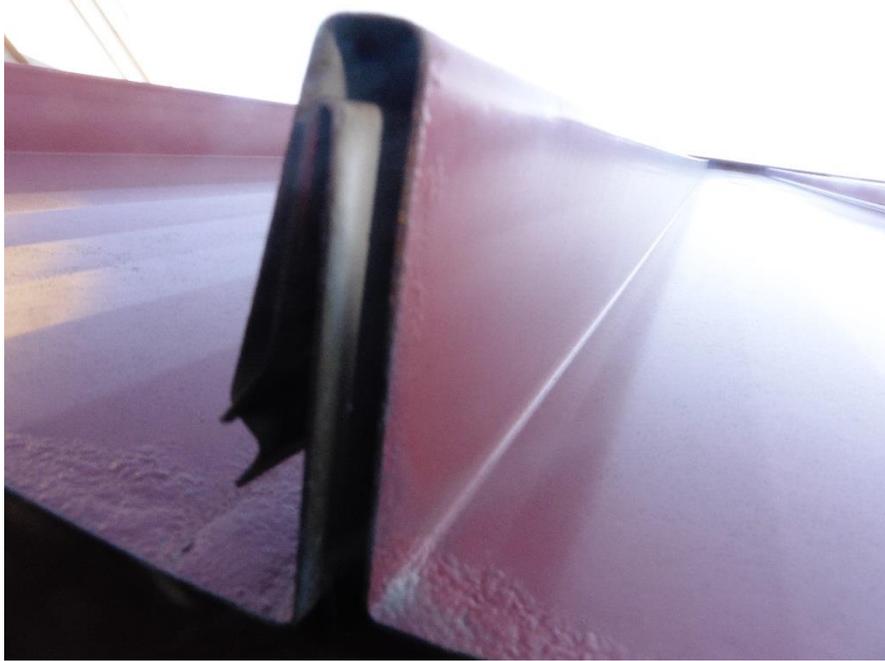
This close up photo of the standing seam roof panel shows the open seam end is susceptible to wind driven rain.

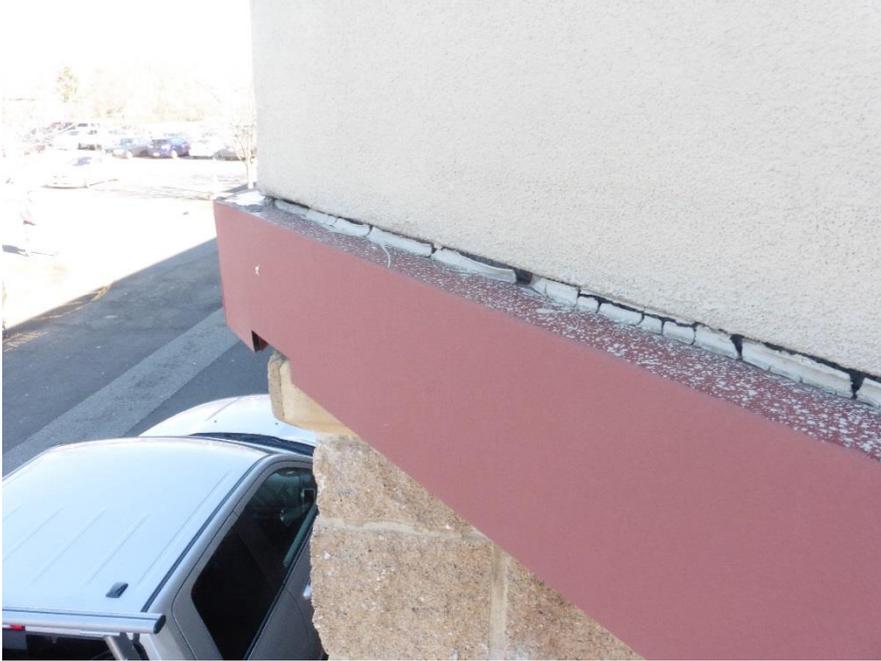
Failure of the caulking joint at the corner jog in the front facade.

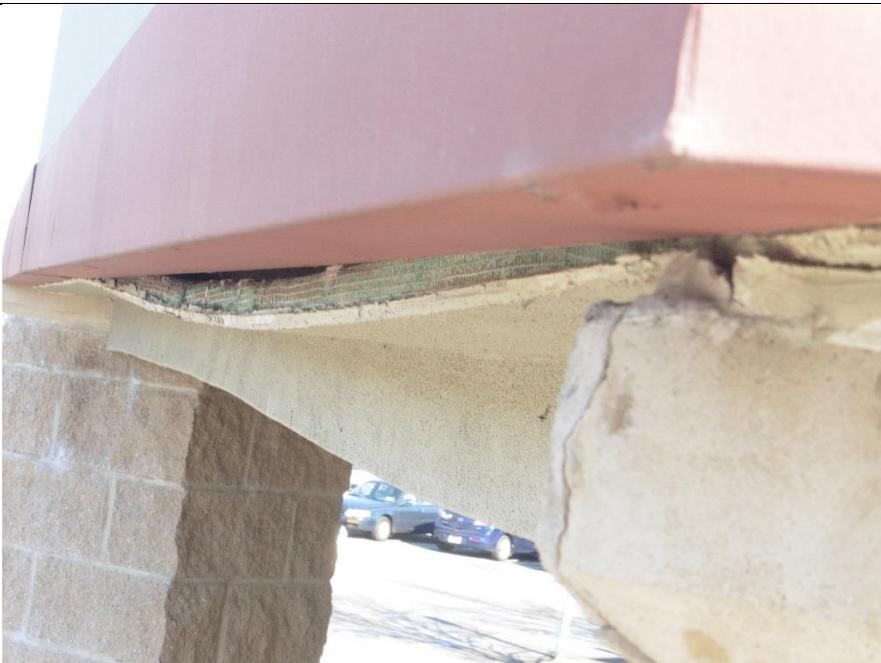
Drooping, failing EIFS at soffit on west portion of west entrance roof. This is a result of chronic seepage into soffit and lack of maintenance.

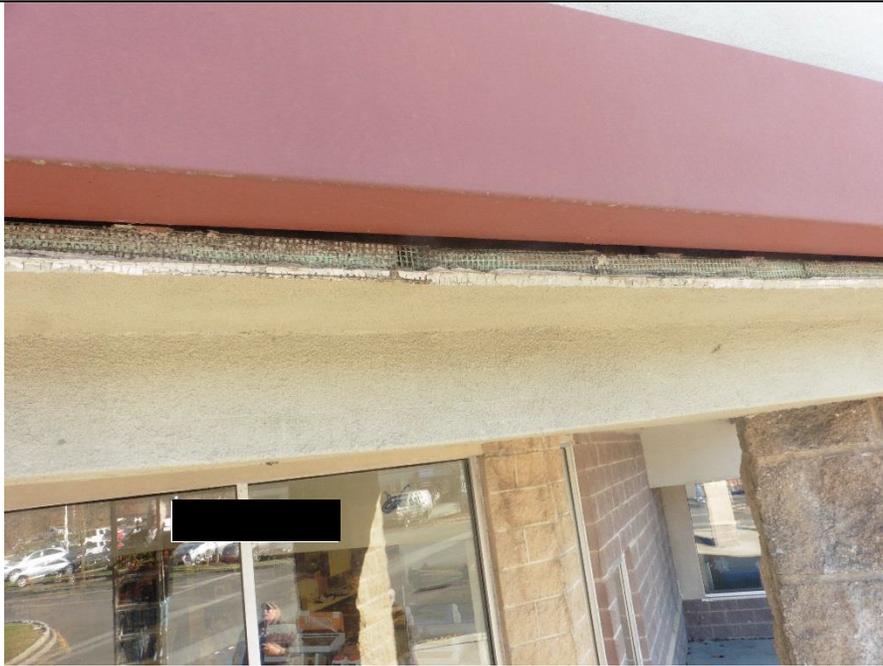
Soffit separation.

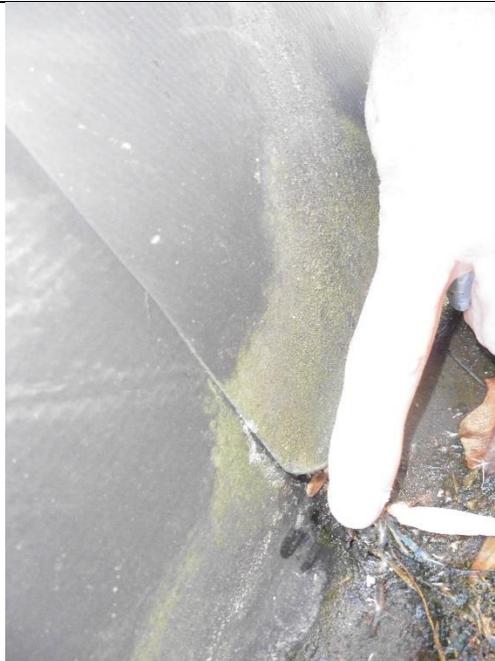
- The rubber gutter lining has un-adhered portions of seams. This could result in leakage into the soffit. The uncured rubber patches required at the seam joints when they transition at a slope were not installed. This is a workmanship issue with the original installation which may result in seam failure in the lower corners of the gutter and subsequent seepage.

Failing seam in rubber gutter lining lacks an uncured patch required during original installation.

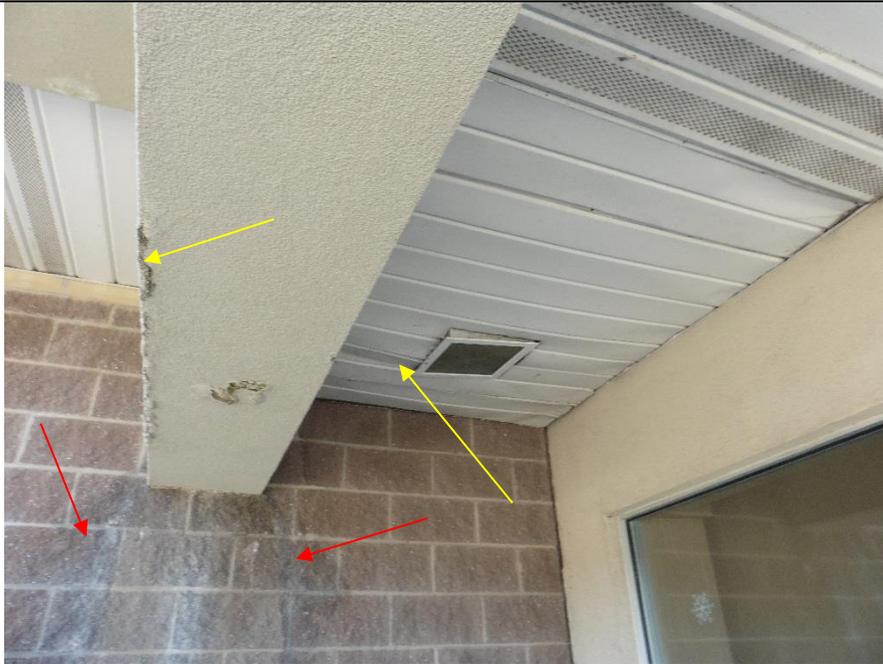
Soffit damage (yellow) and efflorescence (red, mineral stains) in the masonry from chronic seepage from the gutter above.

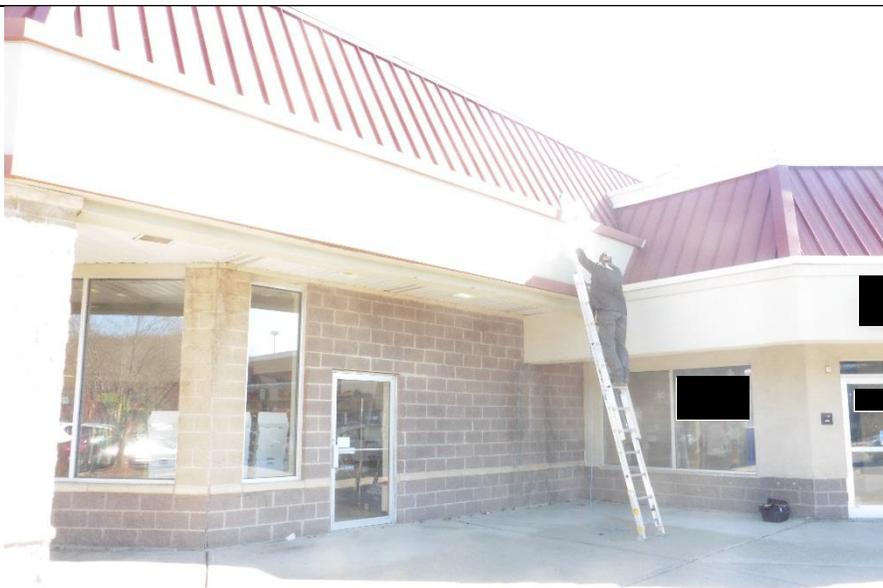
The areas of the worst soffit damage are to the left of the [REDACTED] bank.
