Roofing & Risk

Five Signs of Intentional Roof Damage

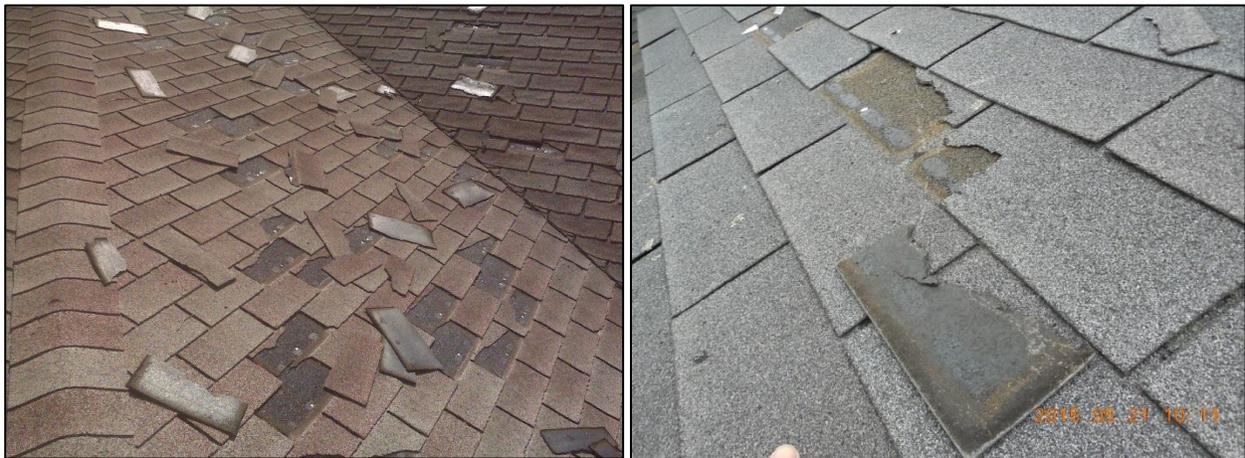
1) Shingles remain on the roof surface

Wind that is strong enough to defeat the tensile strength of the fiberglass core of an asphalt shingle is also strong enough to carry that ripped shingle off the roof. Wind cannot violently tear a shingle and then place it a few feet from its original location. A roof covered in detached shingles is heavily indicative of intentional damage.

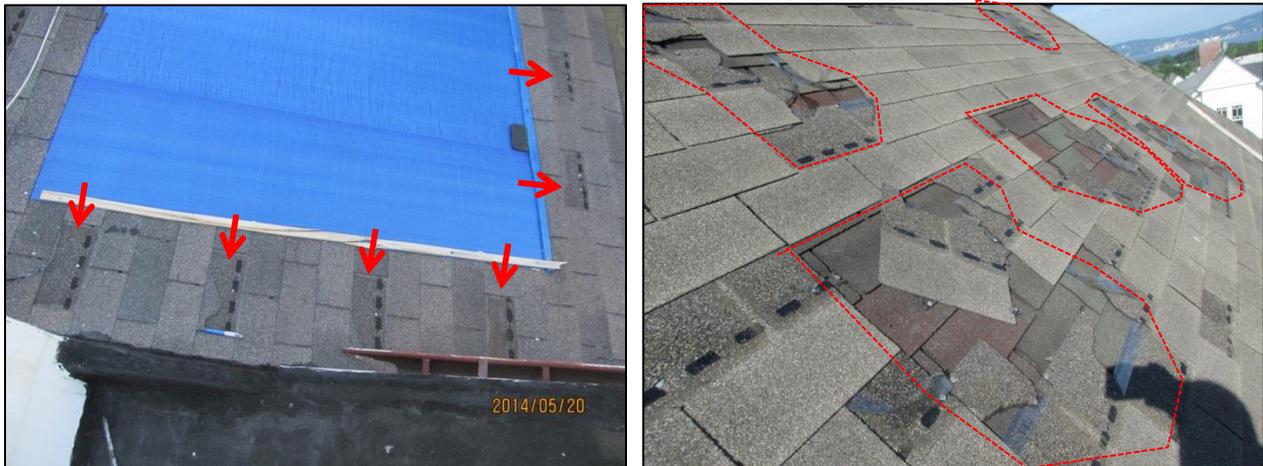
2) Damage is non-random, large-scope

Storm forces most often exploit shingles whose adhesive tar strips that seal them to the course below have failed. These failures, occurring seldom and randomly, result in wind damage that is also random and small in scope. Damage that is non-random (occurring in a discernable pattern) or over large patches of roofing should be considered suspect.

- Damage that occurs along a straight line up or across a roof section
- Damage that occurs to every other course without a corresponding fastening issue
- Damage that occurs to easy-to-access (but not steep roof) sections

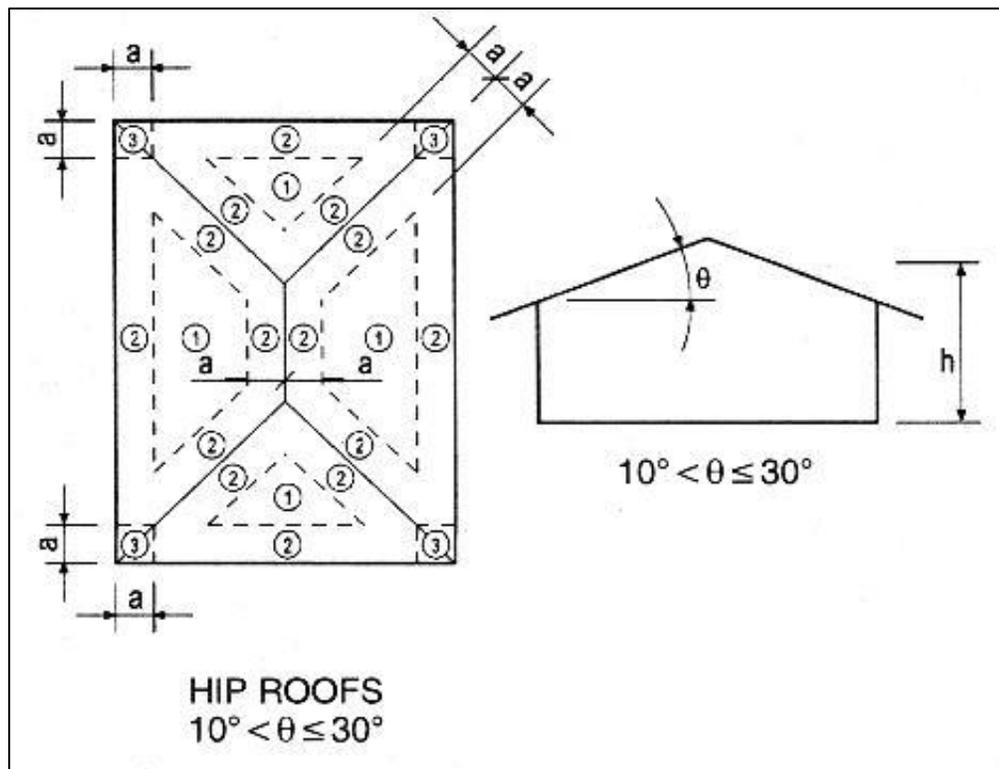
An excerpt from the New York State Residential Code, [R301.2\(7\)](#), *Component and Cladding Pressure Zones*. Zone 3 (corners of roof) is most likely to sustain wind damage, while Zone 1 (field of roof) is least likely to sustain wind damage.

Wind, due to its nature as a vector (having a direction and a magnitude), will damage sections of structures and roofing that are most exposed to the wind. This includes the windward sides of a structure on the date the wind occurred, as well as the perimeter of the roof (rakes, ridges, eaves, hips, etc.). Interior portions of roofing, such as valleys and the field of the roof, and leeward sides of roofing, are least susceptible to wind damage. Building codes adopted by states often include diagrams of roofing that show which sections are most and least susceptible to wind damage. A storm with sufficient winds to damage roof systems will normally only affect one or two windward sides of a structure.

A roof system that is damaged on all sides, or is only damaged heavily in its field without any perimeter damage, may be suspect.

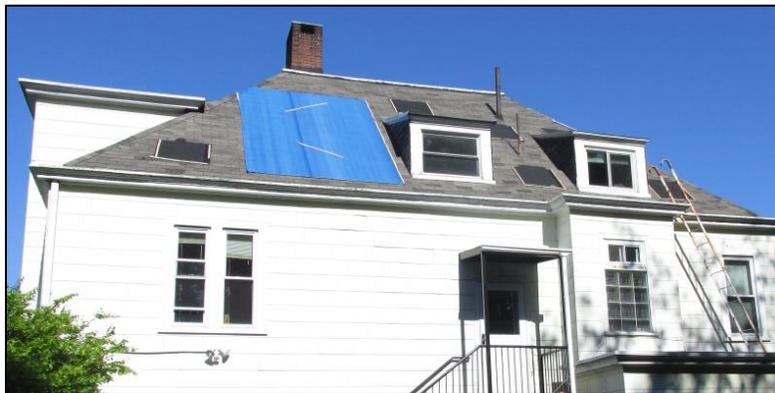
4) Excessive use of tarps for small losses

Temporary repairs and the installation of tarps often increase the scope of damage when nails used to secure the repairs/tarps create new holes in the roof system. Large tarps that only cover a few missing shingles should be a red flag, as this may be used to inflate the perceived scope of damage.

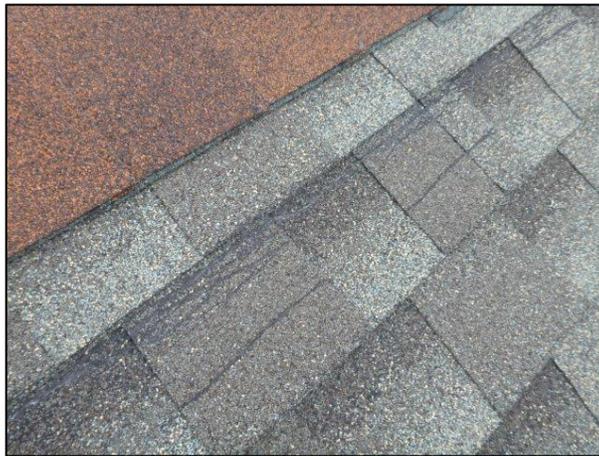
Horizontal creases in wind-damaged shingles.

Horizontal creases in shingles are the hallmark of wind damage. An extensively damaged roofing system without the presence of any creases in the shingles should be considered suspect.

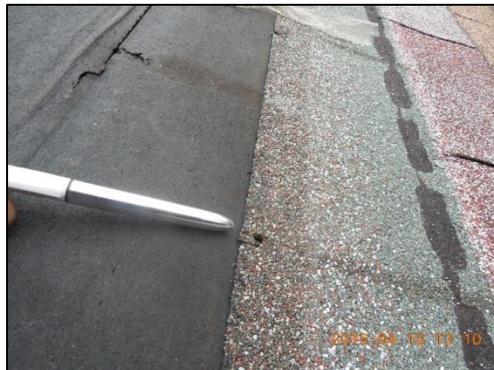
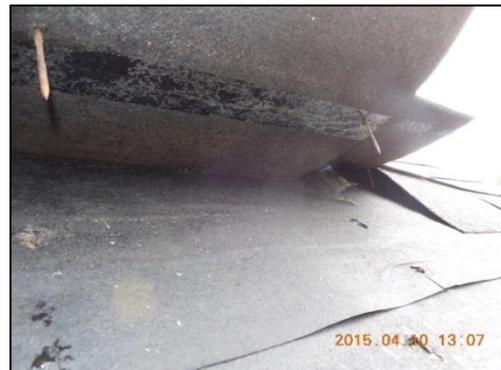
b. Pulled nails

Removing roofing nails from solid wood sheathing requires a great, specific force. Partially or totally removed nails in conjunction with undamaged shingles is indicative of nails removed with a tool. Legitimately wind-damaged shingles will tear/fail around the nails used to secure them to the roof, leaving the nails in place in the sheathing.

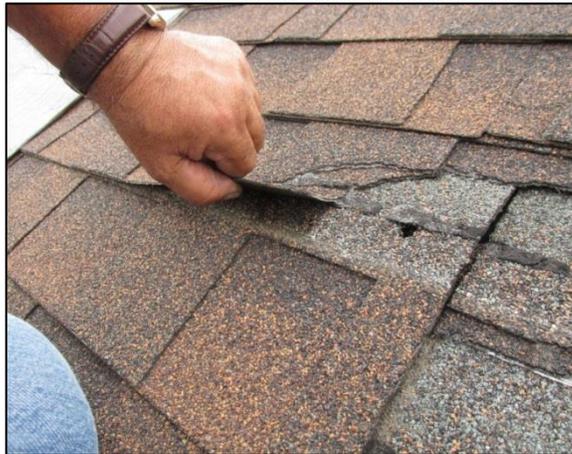
Tar adhesive strip is intact and adhered on left side while fiberglass core of shingle is torn. This indicates intentional damage.

Shingles that have been ripped at their strongest point (fiberglass core), yet are still intact at their weakest point (tar adhesive strip) indicate that a specific mechanical force was applied to the shingles, often with a roofing tool such as a shovel or flat bar. Wind will exploit the weakest part of the shingle.
